NASA SP-238

APOLLO 11

Mission Report

PREPARED BY
MISSION EVALUATION TEAM
NASA MANNED SPACECRAFT CENTER

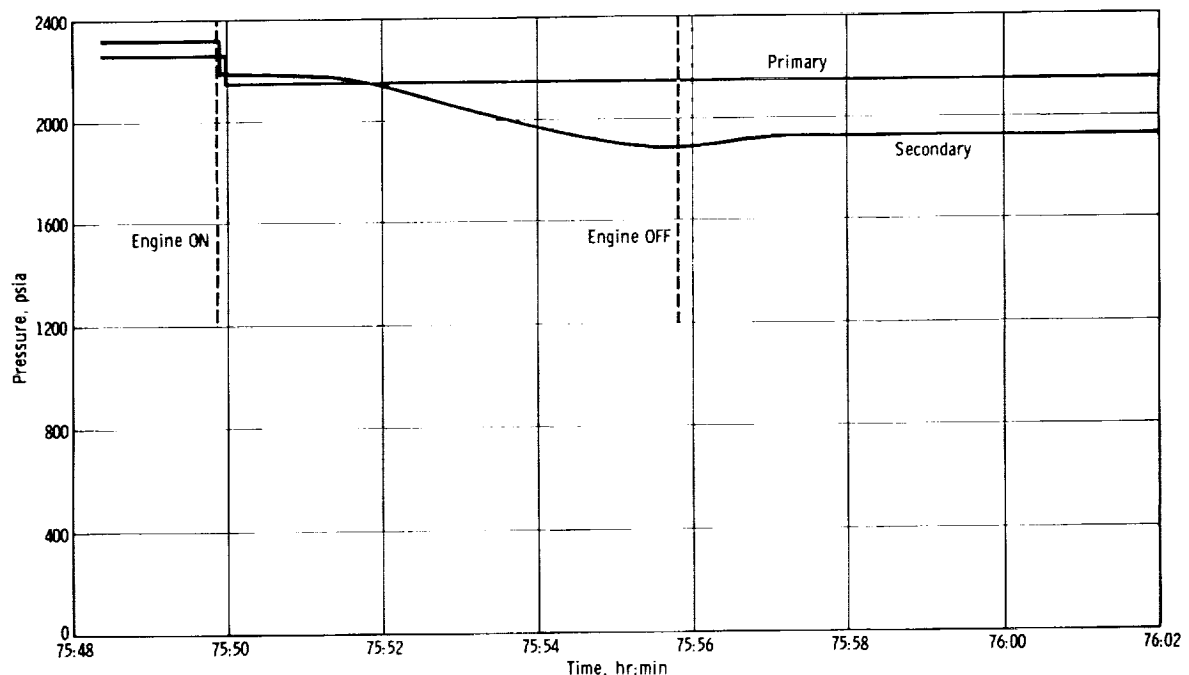
Figure 16-1.- Nitrogen pressure during initial lunar orbit insertion firing.

Service propulsion nitrogen leak.- During the lunar orbit insertion firing, the gaseous nitrogen in the redundant service propulsion engine actuation system decayed from 2307 to 1883 psia (fig. 16-1), which indicated a leak downstream of the injector prevalve. The normal pressure decay as experienced by the primary system is approximately 50 psia for each firing. Only one system was affected, and no performance degradation resulted. This actuation system was used during the transearth injection firing, and no leakage was detected.

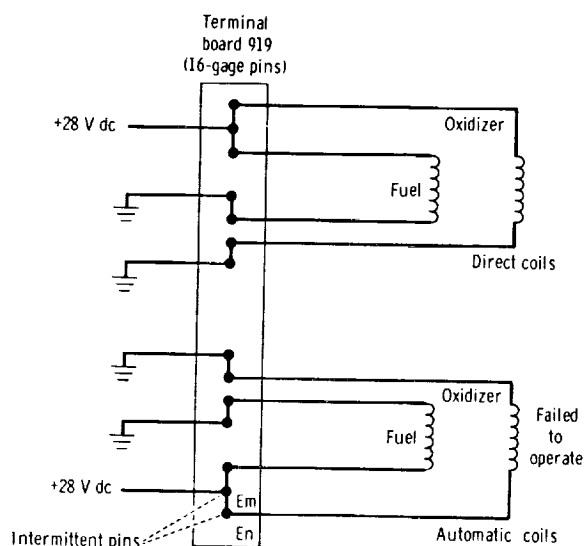
Figure 16-3.- Terminal board schematic for minus-yaw engine, command module reaction control system 1.

Postflight tests showed that two pins in the terminal board (fig. 16-3) were loose and caused intermittent continuity to the automatic coils of the engine valve. This type

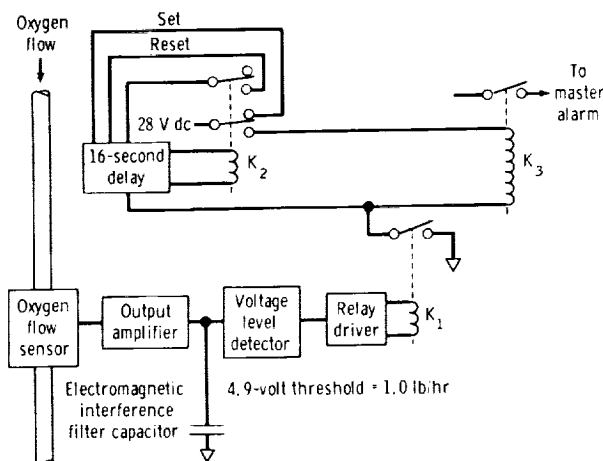
Figure 16-4.- Oxygen flow sensing circuit.

Oxygen flow master alarms.- During the initial lunar module pressurization, two master alarms were activated when the oxygen flow rate was decreasing from full scale. The same condition had been observed several times during altitude chamber tests and during subsequent troubleshooting. The cause of the problem could not be identified before launch, but the only consequence of the alarms was the nuisance factor. Figure 16-4 shows the basic elements of the oxygen flow sensing circuit. Note in figure 16-4 that, for a master alarm to occur, relay K1 must hold in for 16 seconds, after which time relays K2 and K3 will close, activating a master alarm.

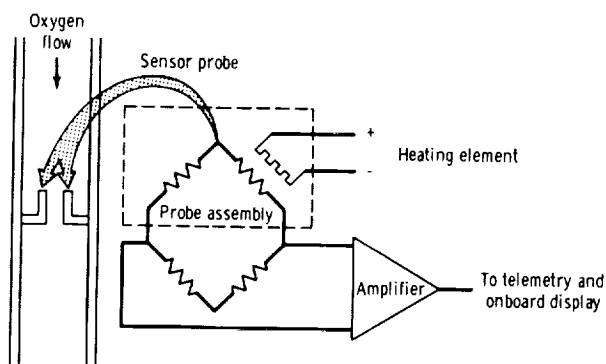
Figure 16-5.- Oxygen flow sensor.

Analysis of associated data indicated that the oxygen flow was normal, but that the indicated flow rate was negatively biased by approximately 1.5 lb/hr. Postflight tests of the transducer confirmed this bias, and the cause was associated with a change in the heater winding resistance within the flow sensor bridge (fig. 16-5). The resistance of the heater had increased from 1000 to 1600 ohms, therefore changing the temperature of the hot wire element that supplies the reference voltage for the balance of the bridge. Further testing to determine the cause of the resistance change was not practical because of the minute size of the potted resistive element. Depotting of the element would destroy available evidence of the cause of failure. Normally, heater resistance changes occur early in the 100-hour burn-in period during which heater stability is achieved.

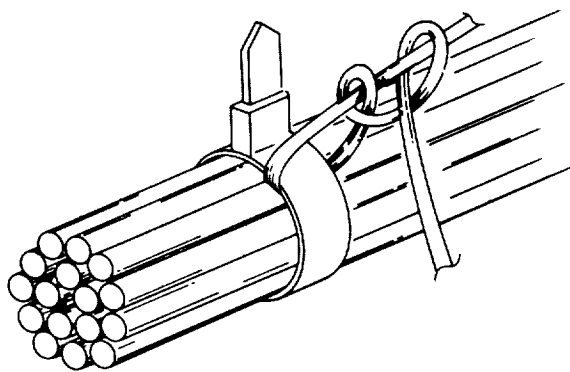
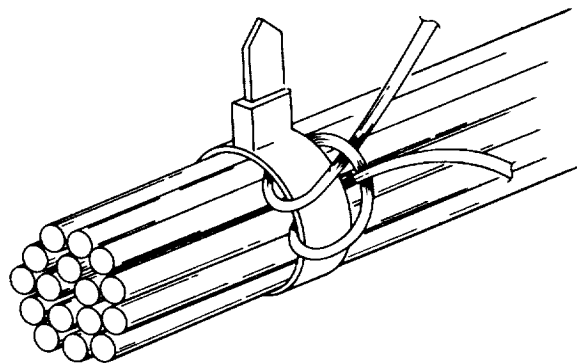
After the lanyard breaks the tie-wraps, if the fragment of tie-wrap pulls out of the knot, the clove hitch knot can untie, thus lengthening the lanyard. Lengthening this lanyard as the umbilical cable pays out can allow transfer of some loading into the umbilical disconnect fittings. Should a sufficient load be transferred to the disconnect fitting to cause shearpins to fail, the mortar umbilical of the forward heat shield could be disconnected prior to the mortar firing. This disconnection would prevent deployment of the forward heat shield separation-augmentation parachute, and there would be a possibility of forward heat shield recontact with the command module. Examination of the forward heat shield recovered from Apollo 10 confirmed that the mortar had fired and that the parachute was properly deployed.

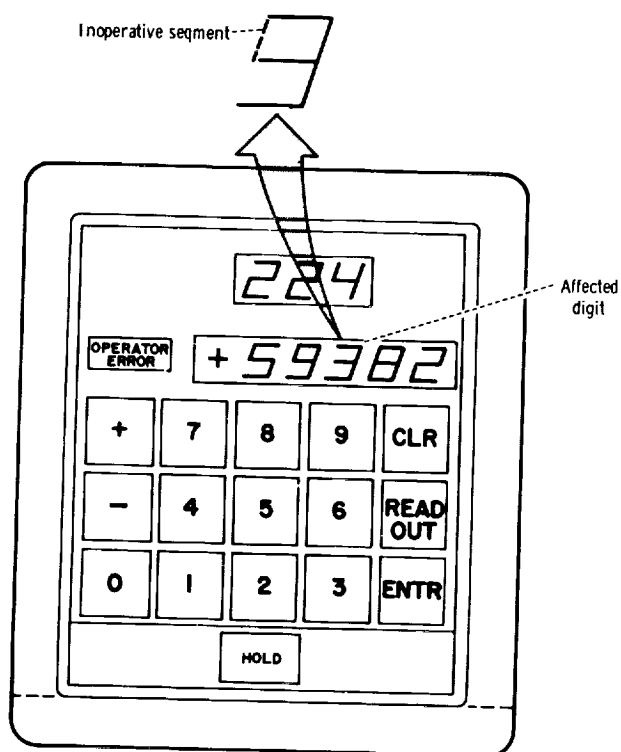
Figure 16-17.- Inoperative segment in one digit of the data entry and display assembly.

After suiting, the Lunar Module Pilot entered the lunar module, the drogue and probe were installed, and the hatch was closed. During the ascent-battery checkout, the variations in voltage produced a noticeable pitch and intensity variation in the already loud noise of the glycol pump. Suit-loop pressure integrity and cabin regulator repressurization checks were accomplished without difficulty. Activation of the abort guidance system produced only one minor anomaly. An illuminated portion of one of the data readout numerics failed, and this failure resulted in some ambiguity in data readout. (See "Electroluminescent Segment on Display Inoperative" in section 16.)
